# WATERTOWN ARSENAL LABORATORY

## EXPERIMENTAL REPORT

NO. WAL 1371

Metallurgical Examination of Bayonets of Commercial and  
Springfield Armory Manufacture

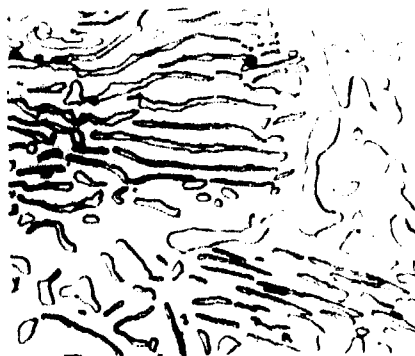
-B-

(2) Lot B - The structure of the critical sections of three of the bayonets of this lot varies from coarse pearlite to spheroidized pearlite as shown in Figures 2 -B-, -V-, and -W-. These variations indicate that the bayonets of this lot did not receive a uniform annealing treatment.

LOT B - CRITICAL SECTION  
COARSE PEARLITE. TRACES OF  
GRAIN BOUNDARY CEMENTITE.  
BAYONET NO. 1.

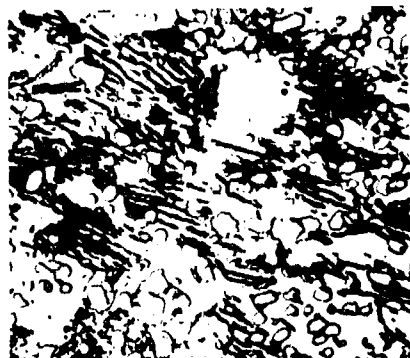
-J-

LOT I 1907 - CRITICAL  
SECTION.  
PEARLITE. SPHEROIDIZED  
CEMENTITE. SMALL FERRITE  
AREAS.

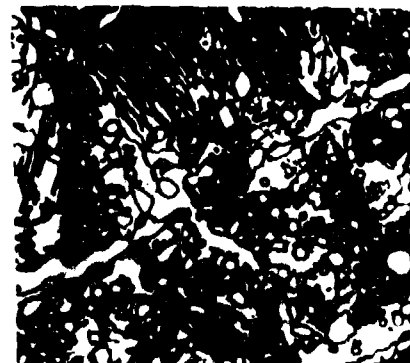
-L-

LOT I 1909 - CRITICAL  
SECTION.  
PEARLITE. SPHEROIDIZED  
CEMENTITE. GRAIN BOUNDARY  
CEMENTITE.

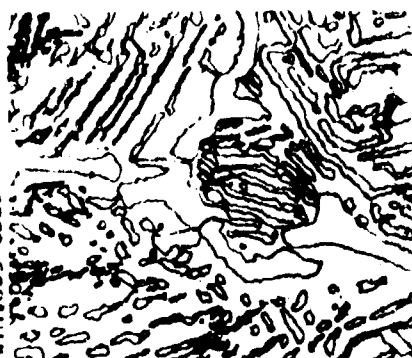
-S-

LOT I 1917 - CRITICAL  
SECTION.  
COARSE PEARLITE. GRAIN  
BOUNDARY CEMENTITE.

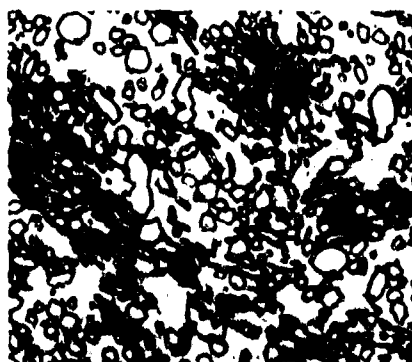
-T-

LOT I 1918 - CRITICAL  
SECTION.  
PEARLITE. SPHEROIDIZED  
CEMENTITE.

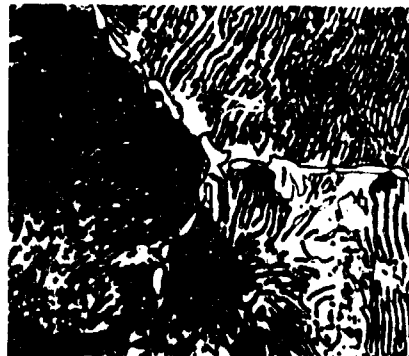
-E-

LOT E - CRITICAL SECTION

PEARLITE, GRAIN BOUNDARY  
CARBIDES, BAYONET NO. 1

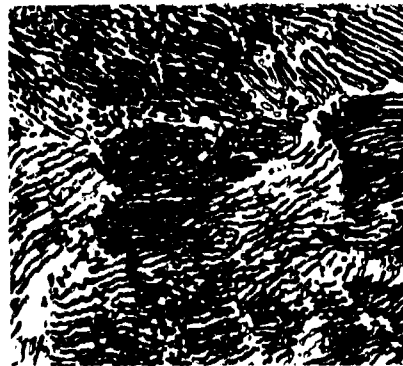
LOT I 1915 - CRITICAL SECTION  
PEARLITE.

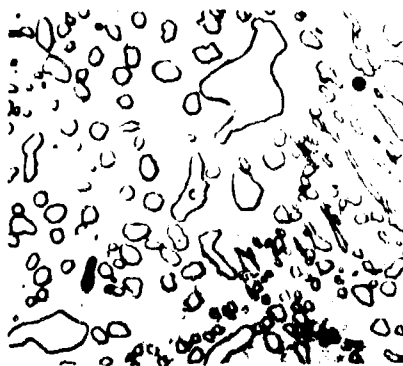
(4) Lot D - The structure at the critical section of Bayonet No. 2 of this lot consists of spheroidized cementite with traces of pearlite as shown in Figure 2 -Z-. The tang of this bayonet is in the unhardened condition whereas the tangs of the other three bayonets of this lot were hardened starting at a point about 1" from the front of the guard. This indicated that bayonets of this lot were not immersed to the same depth in the bath used for heating.

LOT D - CRITICAL SECTION  
SPHEROIDIZED CEMENTITE.  
TRACES OF PEARLITE.  
BAYONET NO. 2.

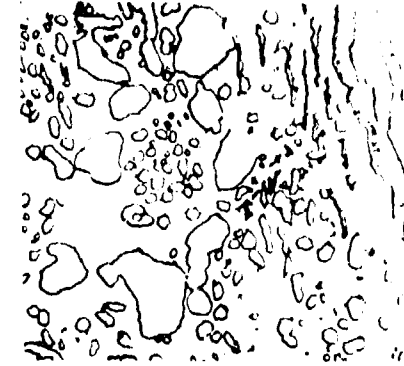
LOT I 1916 - CRITICAL SECTION  
SPHEROIDIZED CEMENTITE.  
MARKED TRACES OF PEARLITE.
